MAIN STREET MASTER PLAN APPENDIX A: ENGINEERING REPORT

December 2021

Appendix A: Deadwood Main Street Master Plan

Engineering Report

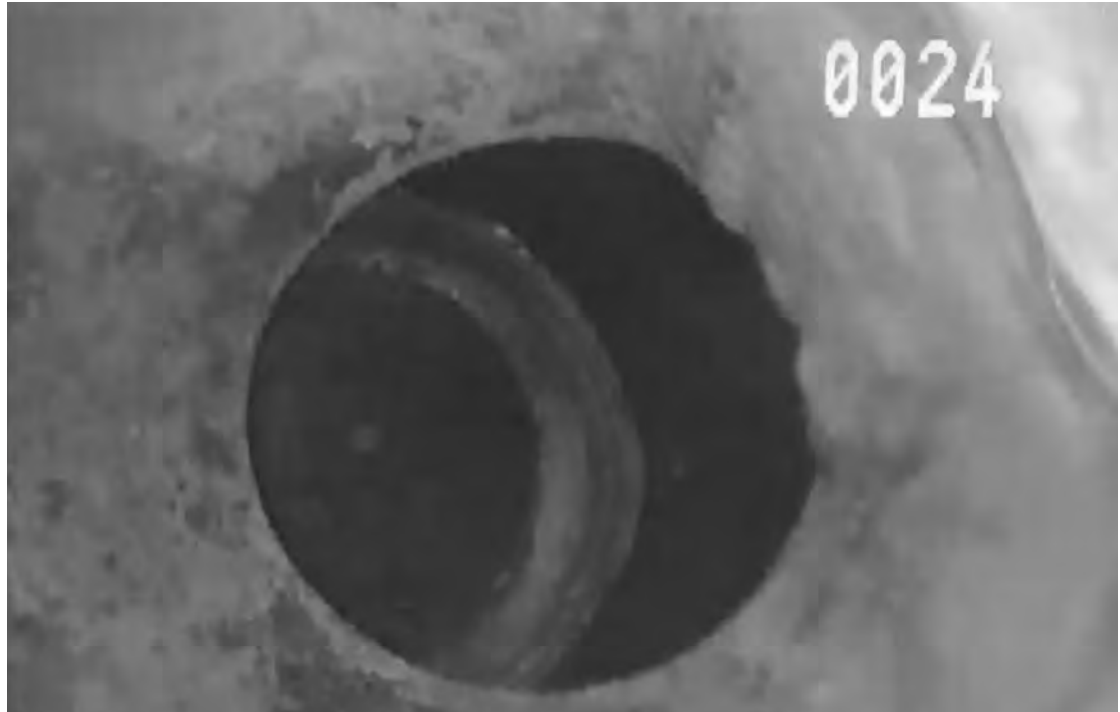
Picture 4 Example of Sewer Service Joint Separation

- **8 Shine Street** – Unable to find cleanout, attempted to pull the interior toilet but were still unsuccessful in videoing due to multiple interior bends.
- **415 Williams Street** – Were not able to contact the owner and gain access to the residence.
- **405 Williams Street** – Were not able to access the service through an internal or external location.
- **37 Lee Street** – Service was drawn in based on discussion with the owner. Tried to access the service through a roof vent without success.
- **667 Main Street** – Could not gain access to the building.
- **668 Main Street** – Gold Dust C-Store – There was a separation in the lateral 25' from the bathroom under the building. The separation was severe enough it appeared to be discharging below the building. (Picture 4)

Five buildings also detected smoke inside during testing, all of which are located along Main Street, between Shine Street and Gold Street. The most significant of these was located at 668 Main Street, which was shown to have lateral separation during the video portion of the sanitary sewer investigation. Other addresses that detected smoke in the building were:

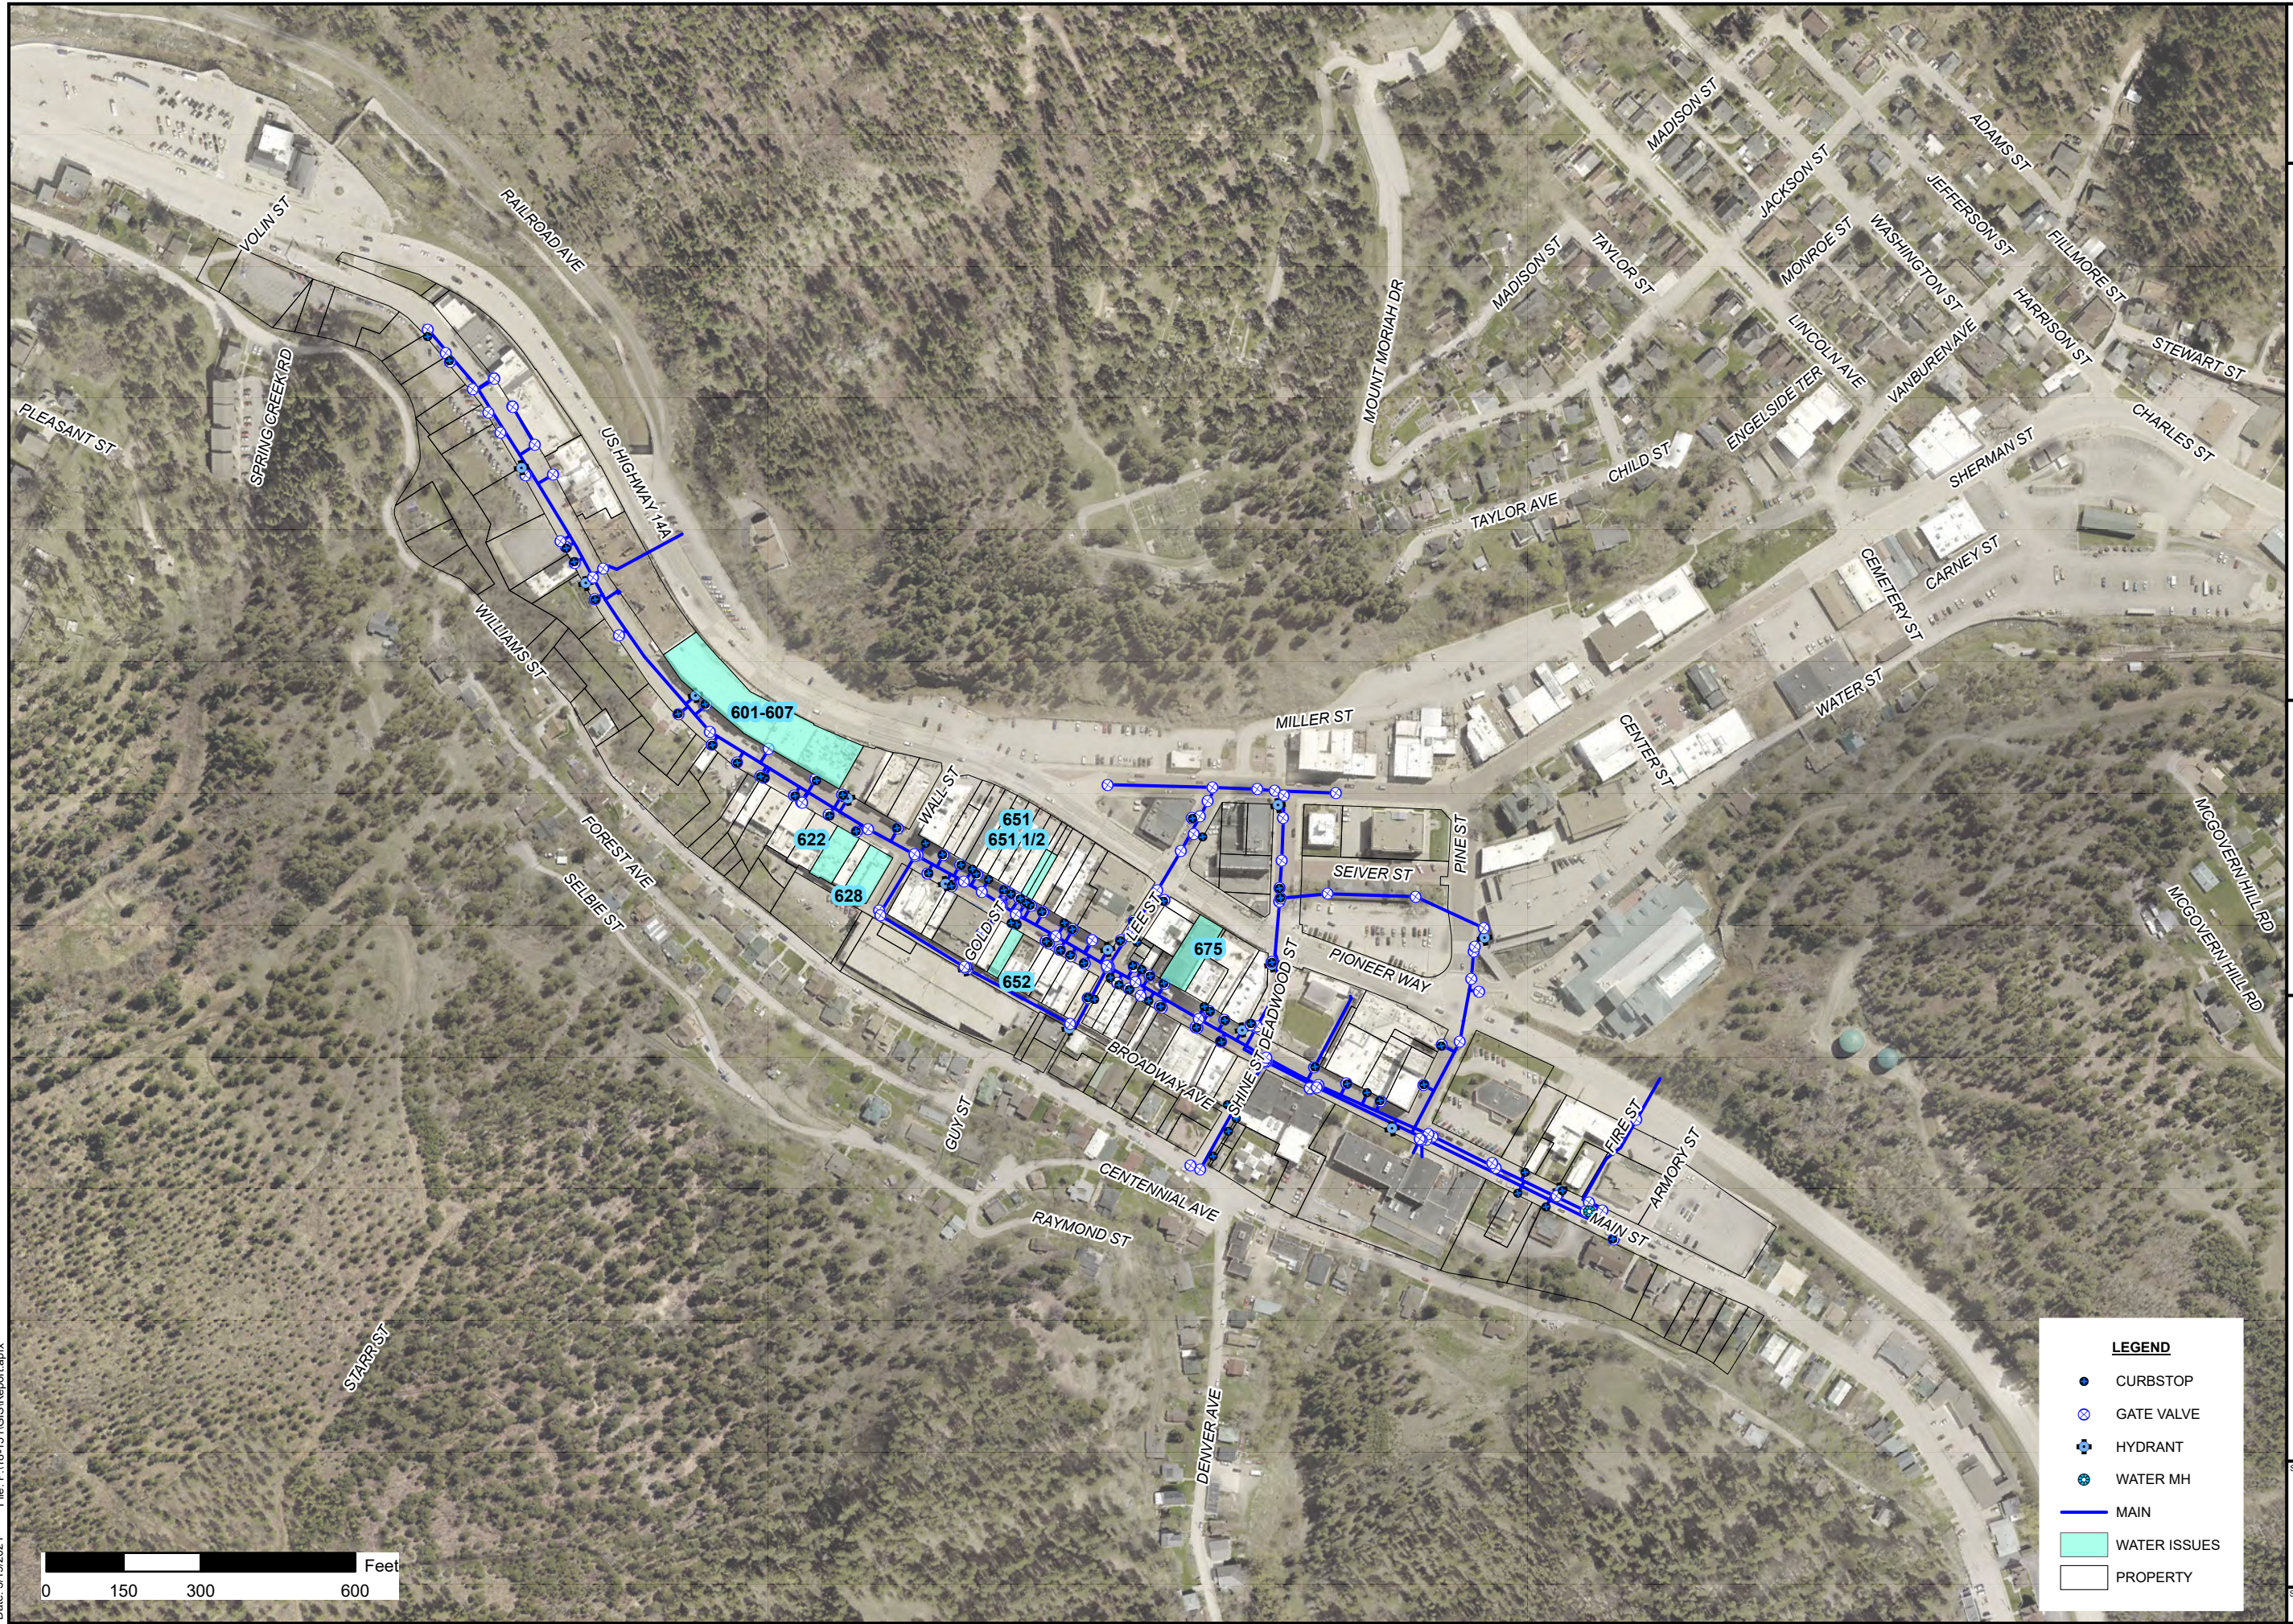
FIGURE 3.
WATER SYSTEM
INVESTIGATION

As mentioned previously, no detailed investigation into the water system (**Figure 3**) was performed, however, based off recently completed FEC work in downtown Deadwood and discussions with Public Works Staff, several potential water service-related issues have been identified. Primary among these concerns is premature corrosion of various water system components. The water system was constructed in the early 1990's and is comprised of a combination of PVC (plastic) pipe and ductile iron (metallic) fittings. Public Works Staff have specifically identified that the bolts on a number of valves have experienced significant corrosion. Corrosion was also evident on metallic components of the water system in Deadwood Street, which was recently reconstructed as part of the Outlaw Square Project as shown below in **Pictures 5 and 6**.

Other issues brought to light in discussions with City staff include a handful of situations in which there are shared water services and/or multiple meters in one building. This is currently known to occur at 628 Main Street, 652 Main Street and 675 Main Street. This is also occurring at the Mineral Palace (601-607 Main Street) where there are four meters coming off a single service inside the building. At 651 and 651 ½ Main Street there is currently a single service and meter supplying two separate business. Similarly at 622 Main Street, there is currently one owner with two tenants being served by a single service and meter.

Prior to or most likely in conjunction with an overall street reconstruction, there is a need to inspect every fitting. At that time, FEC recommends that every valve and metallic fitting be exposed, inspected, and a decision then be made to either wholesale replace the valves and other fittings, replace bolts, and/or connect an anode for further protection. Also, the installation of tracer wire access boxes and the relocation of existing faulty tracer wire from inside the valve to a separate access box will greatly increase the probability of proper system maintenance.

The City Public Works Division would like to see uniformity across the water service system, with one meter per service. In the situations where two businesses are currently sharing a single service and meter, Public Works would prefer to remedy the situation by providing a second service connection and meter during an overall reconstruct to alleviate any potential financial burden on the owners. For 651 and 651 ½ Main Street, there are currently unused existing stub-outs in the street that could be tied directly into the building via directional drilling or some other appropriate method. For 622 Main Street, a new tap, service and meter would need to be installed.
