St. Ambrose Cemetery

A Preservation Master Plan

City of Deadwood
Historic Preservation
Commission
108 Sherman Street
Deadwood, SD 57732

DREAM DESIGN
INTERNATIONAL, INC.

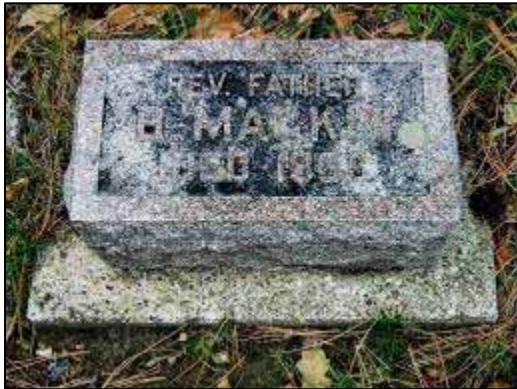
Rev. Father B. Mackin's grave. Father Mackin died in 1880 and is buried in St. Ambrose just north and east of the entrance gate.

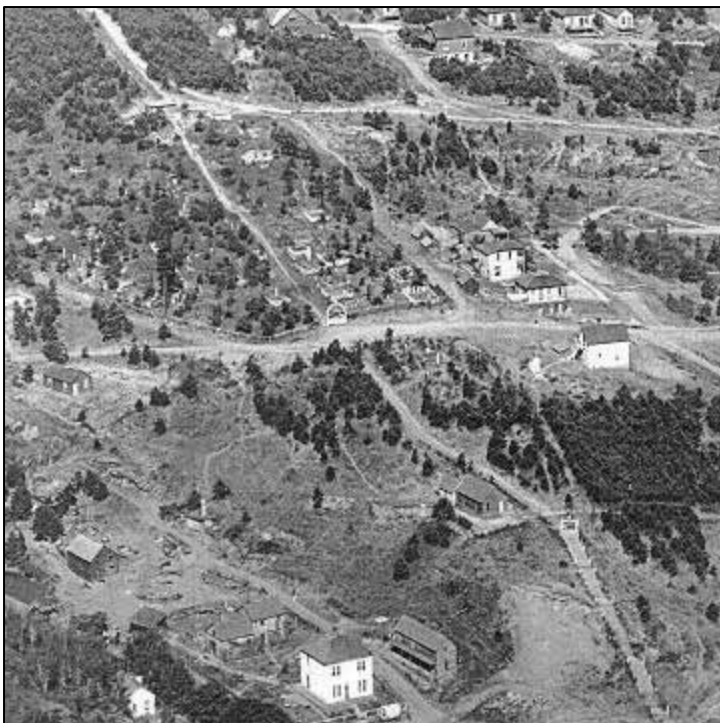
Circa 1900 photo of St. Ambrose Cemetery taken from White Rocks showing original entrance to the cemetery and early gravesites.

A recent discovery of a historic photo showing this area of Deadwood revealed that the entrance walk to St. Ambrose Cemetery traveled up the hillside across from what is now the Lower Main Parking Lot. This photo reveals two gates one about half way up the hill and the other located where the current ornamental iron gate exists. The photo also reveals that there were gravesites below what is now Pleasant Street. This new information was the basis for conducting a preliminary investigative archaeological study which was performed by the South Dakota State Historical Society Archaeological Research Center (SARC) in October of 2006. The preliminary study concluded that evidence exists that supports the presence of gravesites below Pleasant Street. Further, more extensive investigation is

needed to confirm the existence of gravesites and human remains below Pleasant Street. Should this further investigation burials occurred or are present, this area should become part of the recognized boundaries of the St. Ambrose Cemetery.

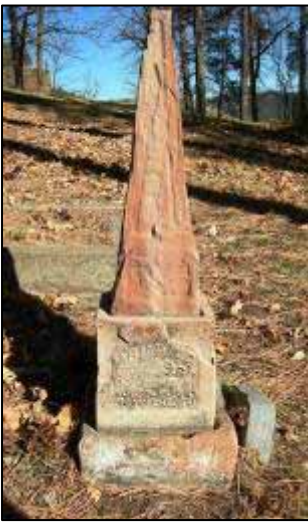
Figure 2.1 – A High Priority monument in need of conservation.

1. High Priority – Monuments in jeopardy of being lost or damaged due to severe degradation, severe tilt, loss of material, loss of genealogical data (barely legible), or vegetation impact. Monuments with high artistic value which need repair or conservation also fall into this category.

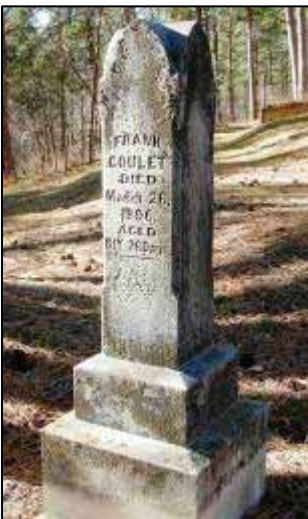
Figure 2.2 – A Medium Priority monument with heavy biological growth.

2. Medium Priority – Monuments which are generally stable or have moderate deterioration but are not in an immediate need for conservation treatments. These monuments should be placed on a schedule to be monitored at regular intervals such as every two years to monitor their rate of deterioration and identify maintenance and conservation needs as they develop.

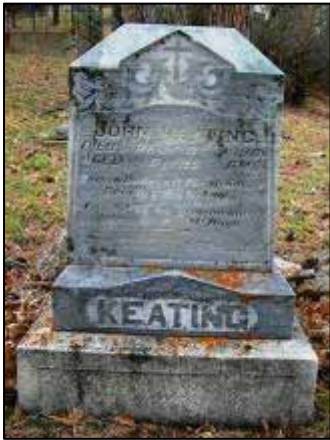
3. Low Priority – Monuments that are in good condition or a very stable condition which do not need any conservation treatments at this time. Most of the monuments in this category are comprised of highly durable material such as various granites or high quality marble; have crisp inscriptions, very little biological or general soiling, or have had previous conservation treatment with good results.

Figure 2.3 – A Low Priority gray marble monument with a limestone base in a stable condition.

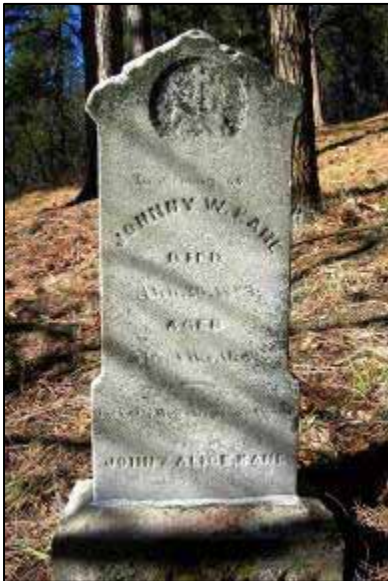
Figure 2.4 – Marble tablet displaying the effects of deterioration due to particle erosion or "sugaring."

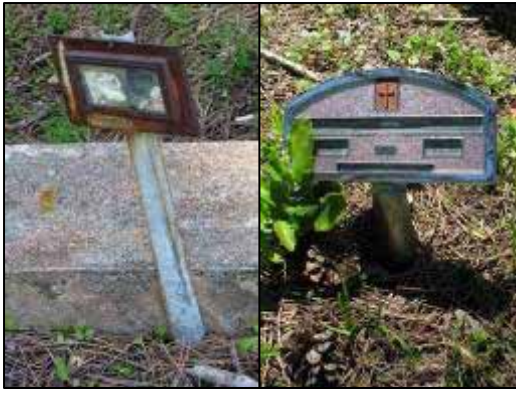
Figure 2.5 – Typical funeral markers that are found in St. Ambrose Cemetery. Many times these simple markers are the only remaining evidence of a gravesite.

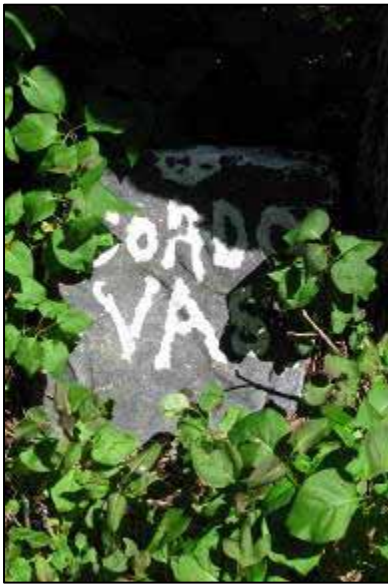
Figure 2.6 – A large painted cobble at the Gordon Vas gravesite.

One of the more uncommon monuments exists at the Gordon Vas plot where a field stone has Mr. Vas’ name painted on it in white. As with the funerary markers, it could be assumed that a manufactured monument could not be afforded for the Vas plot and one was created using what was available. This monument provides an interesting element to St. Ambrose nonetheless.

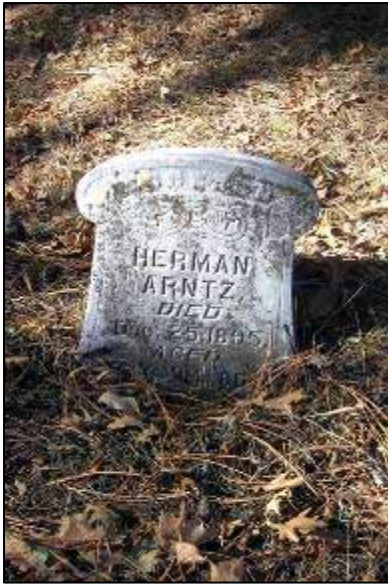
The Herman Arntz monument as it existed in February of 2005. The monument was sunken and severely tilted backward.

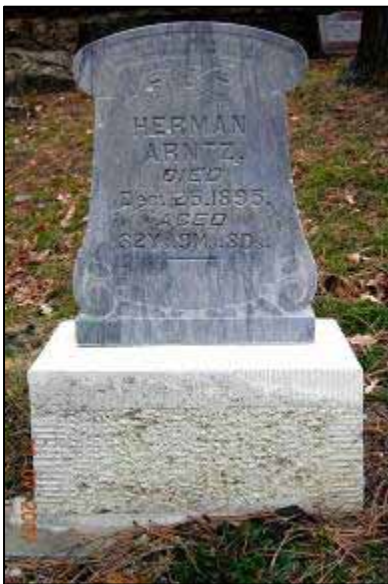
The Herman Arntz monument in 2007 after conservation treatments including resetting, cleaning and stone repair mortars.

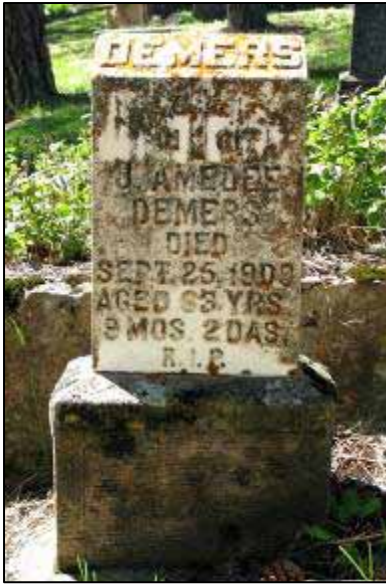
The marble headstone and limestone base at the Demers gravesite would be a good candidate for cleaning.

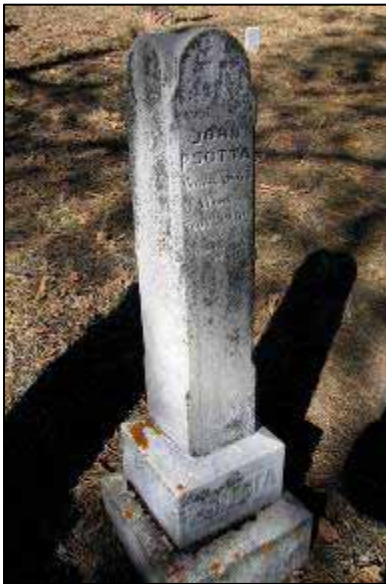
The John Psotta monument prior to cleaning. This monument was included in a marker cleaning workshop in 2005.

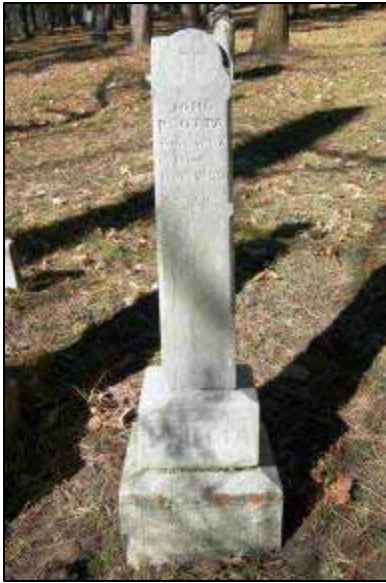
The John Psotta monument as photographed in November, 2007. Biological growth has not returned in the 4 years since cleaning.

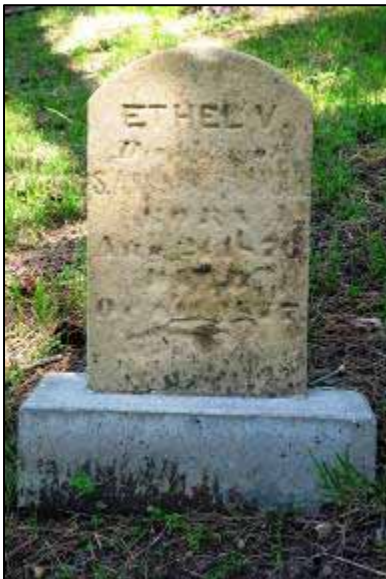
This small sandstone monument is a high priority candidate for stone consolidation. Much of the gravestone data has been lost but what remains is in dire need of conservation.

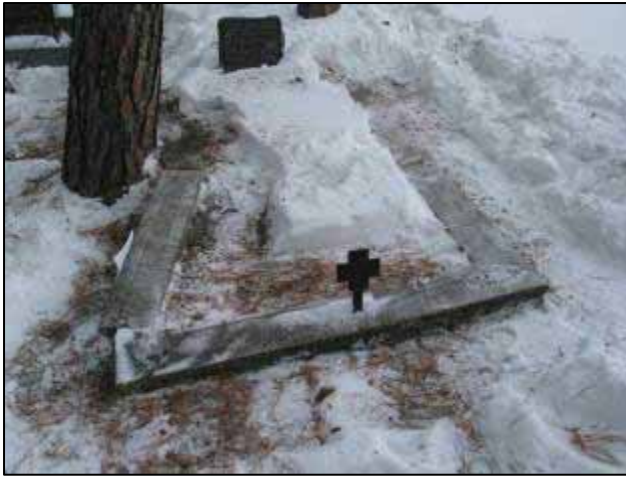
Photo 3.1 - Vegetation Forces

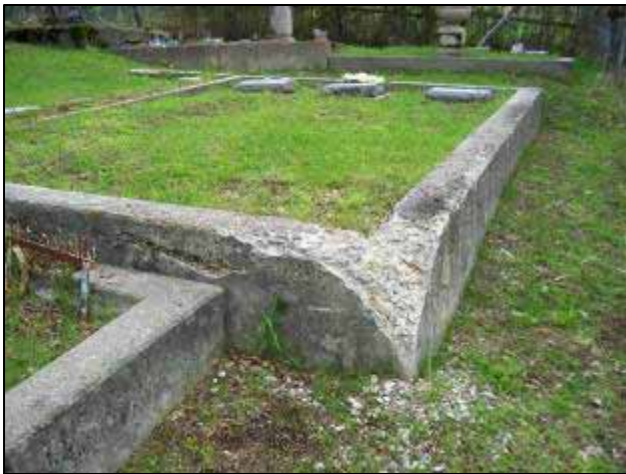
Photo 3.2 - Freeze-Thaw Deterioration

Freeze-thaw deterioration is commonly associated with inadequate air-entrainment in the concrete. There is a limited amount of air that is naturally entrained in concrete by the mixing process. Additional air can be entrained in the concrete with chemical admixtures. Once the concrete has hardened these

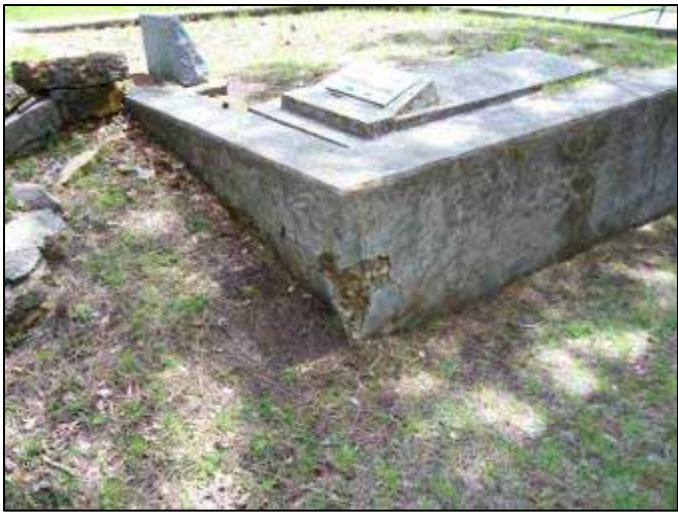
Photo 3.3 - Surface Spalling

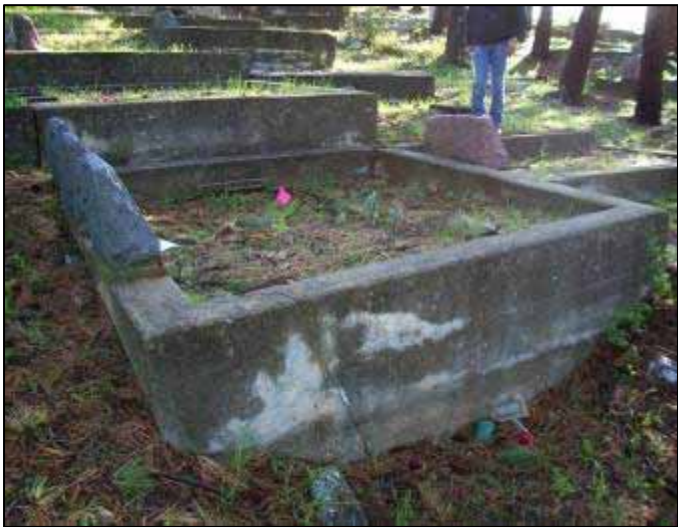
Photo 3.4 - Small Crack

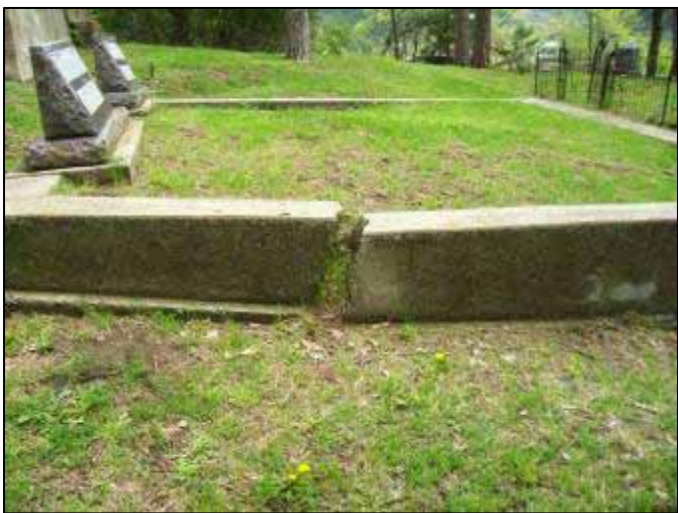
Photo 3.5 - Large Crack

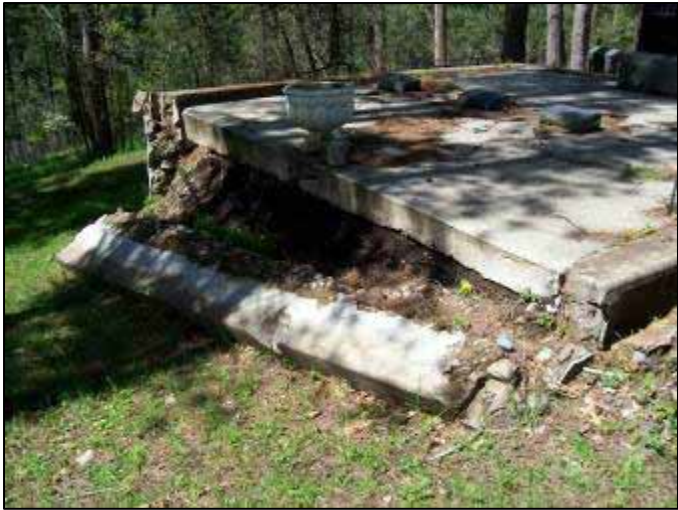
Figure 3.6 – Wall Replacement Example

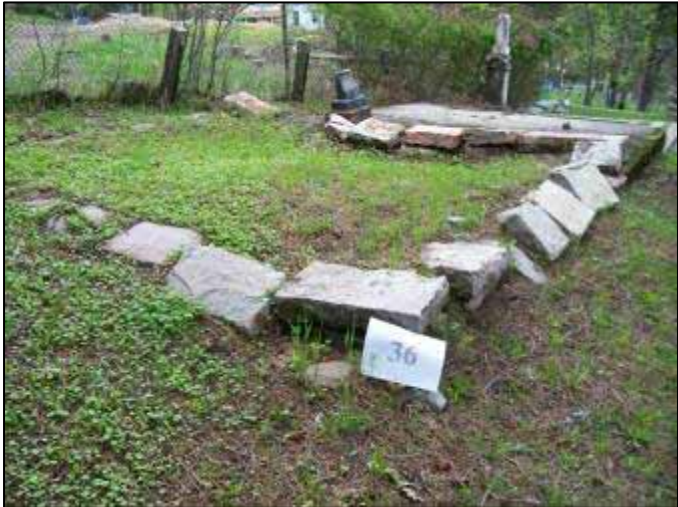
Figure 3.7 – Stacked Dry Stone Wall

6. Backfill after each course is complete. If possible, use a free-draining material behind the wall to prevent excessive water pressures.
7. If possible, provide “deadman” stones at approximately every 16 square feet of wall. Deadmen stones are relatively long stones that are placed perpendicular to the wall and help tie the wall into the material being retained. These will need to be placed very carefully depending upon proximity to graves.
8. The wall should be capped with a large capstone. The capstone should be flat and have a significant mass. This will help hold the stones beneath it and provide a finished look to the retaining wall. As always, the original look of the wall should be maintained.

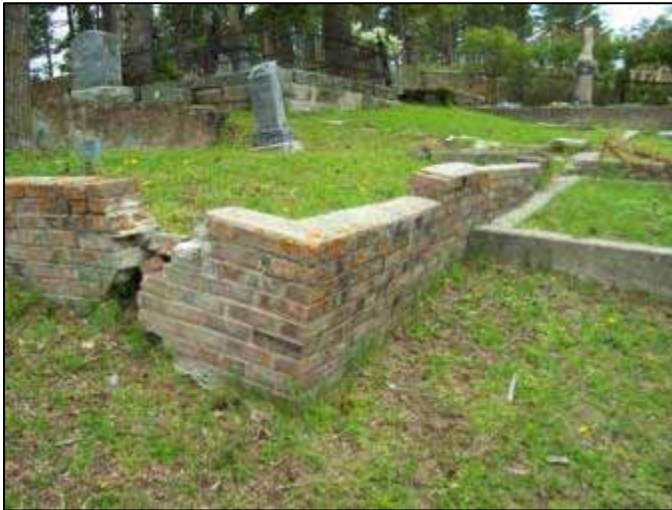
Figure 3.8 – Uneven settlement of brick wall with mortar

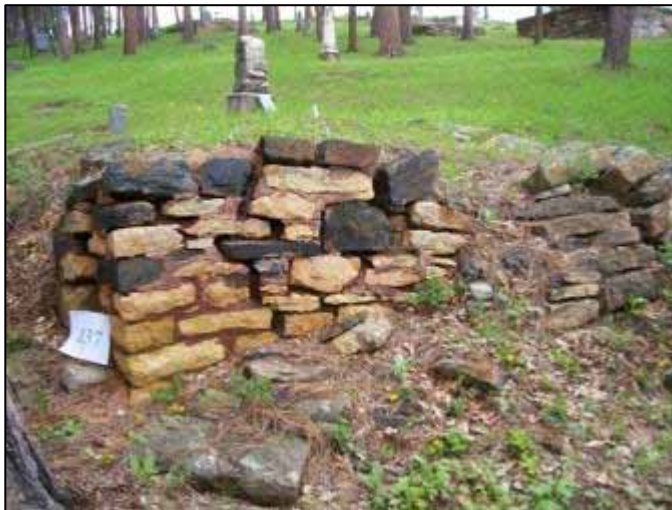
Figure 3.9 – Uneven Settlement of Stone Wall with Mortar

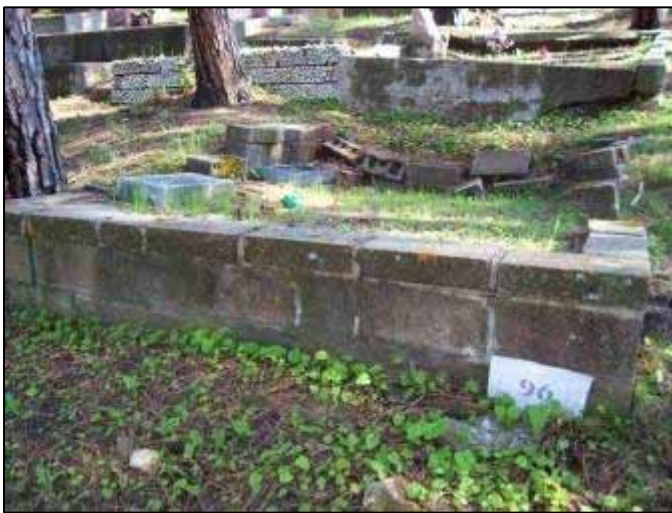
Photo 3.10 – Masonry Wall with Different Levels of Repair

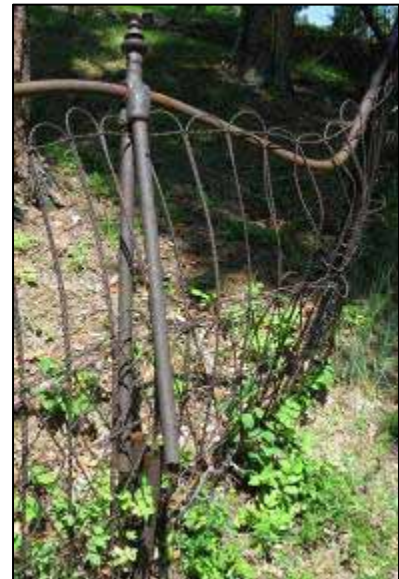
Example of ironwork damaged from falling tree limb.

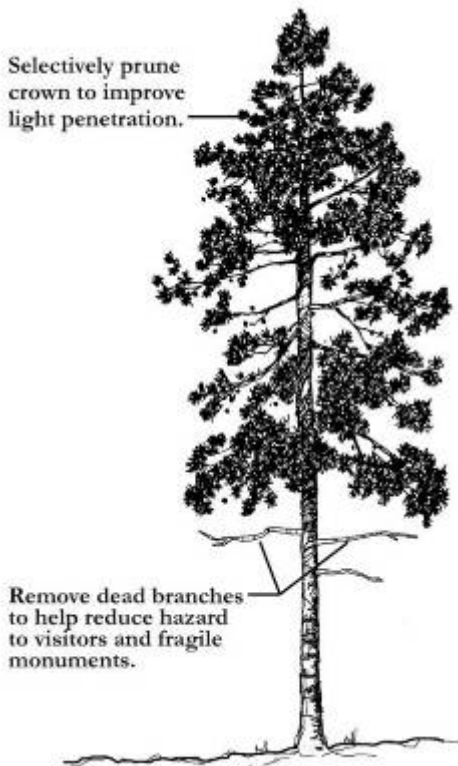
Figure 4.3 – Recommended pruning for coniferous trees within St. Ambrose Cemetery.

the American National Standards Institute (ANSI) document ANSI A300 "Standards for Tree Care Operations."

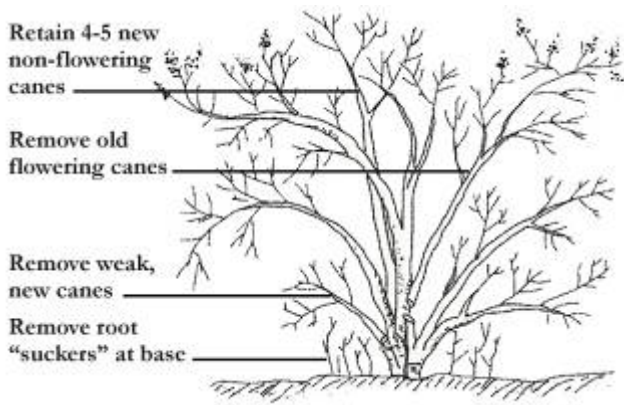
Figure 4.4 – Rejuvenation pruning of Common Lilacs. Remove 1/3 of oldest stems each year for three consecutive years and prune to rounded shape.

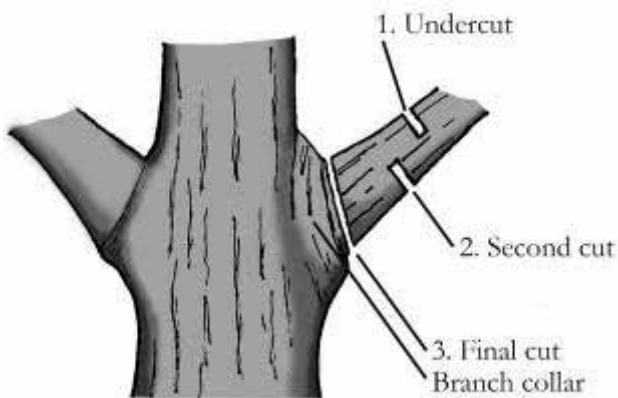
Figure 4.5 – Pruning a Large Limb (applies to both coniferous and deciduous trees)
 1. Undercut 12-24” up from the branch collar to prevent the bark from tearing.
 2. Make the second cut from the top all the way through the branch, 2-3” above cut #1.
 3. The final cut should be just beyond the branch collar. Support the stub so it does not tear the bark.

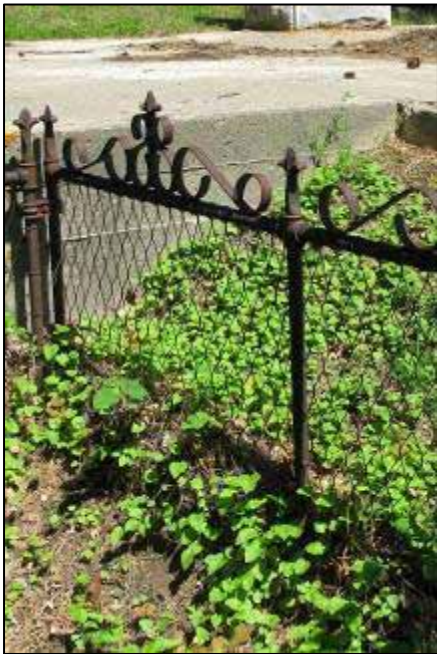
Plant litter and soil building up along plot fence is a factor in deterioration of the bottom portion of this ornamental iron fence.

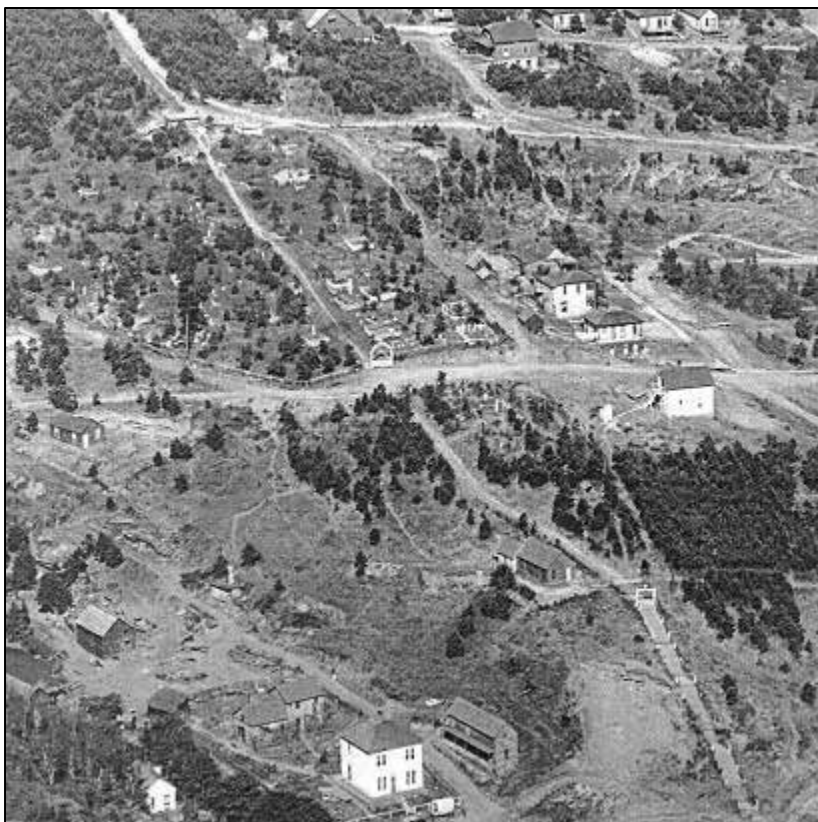
Historic photo taken from White Rocks looking toward St. Ambrose. The photo provides evidence of the entrance sequence and existence of graves below Pleasant Street.

Investigations in separated section of the cemetery. Historic records such as previously located deed records and historic photographs of the cemetery are very useful in providing confirmation of the historic site boundary and historic site overview of the St. Ambrose Cemetery. The deed record indicates that the lower section of St. Ambrose Cemetery, divided by Pleasant Street from the main section, is inclusive in the historic boundaries of the cemetery. The Lawrence County Courthouse Register of Deeds holds Quitclaim Deed #51371 dated April 25, 1890 in which Mrs. Pamela M. Burnham deeded to St. Ambrose Cemetery a triangular piece of property in the southeastern part of townsite Lot No. 297, "...being 150 feet in length at its base...and 160 feet in length...on each of its two sides..." (Record of Deeds, pg.155)
