MAIN STREET MASTER PLAN APPENDIX A: ENGINEERING REPORT

December 2021

Appendix A: Deadwood Main Street Master Plan

Engineering Report

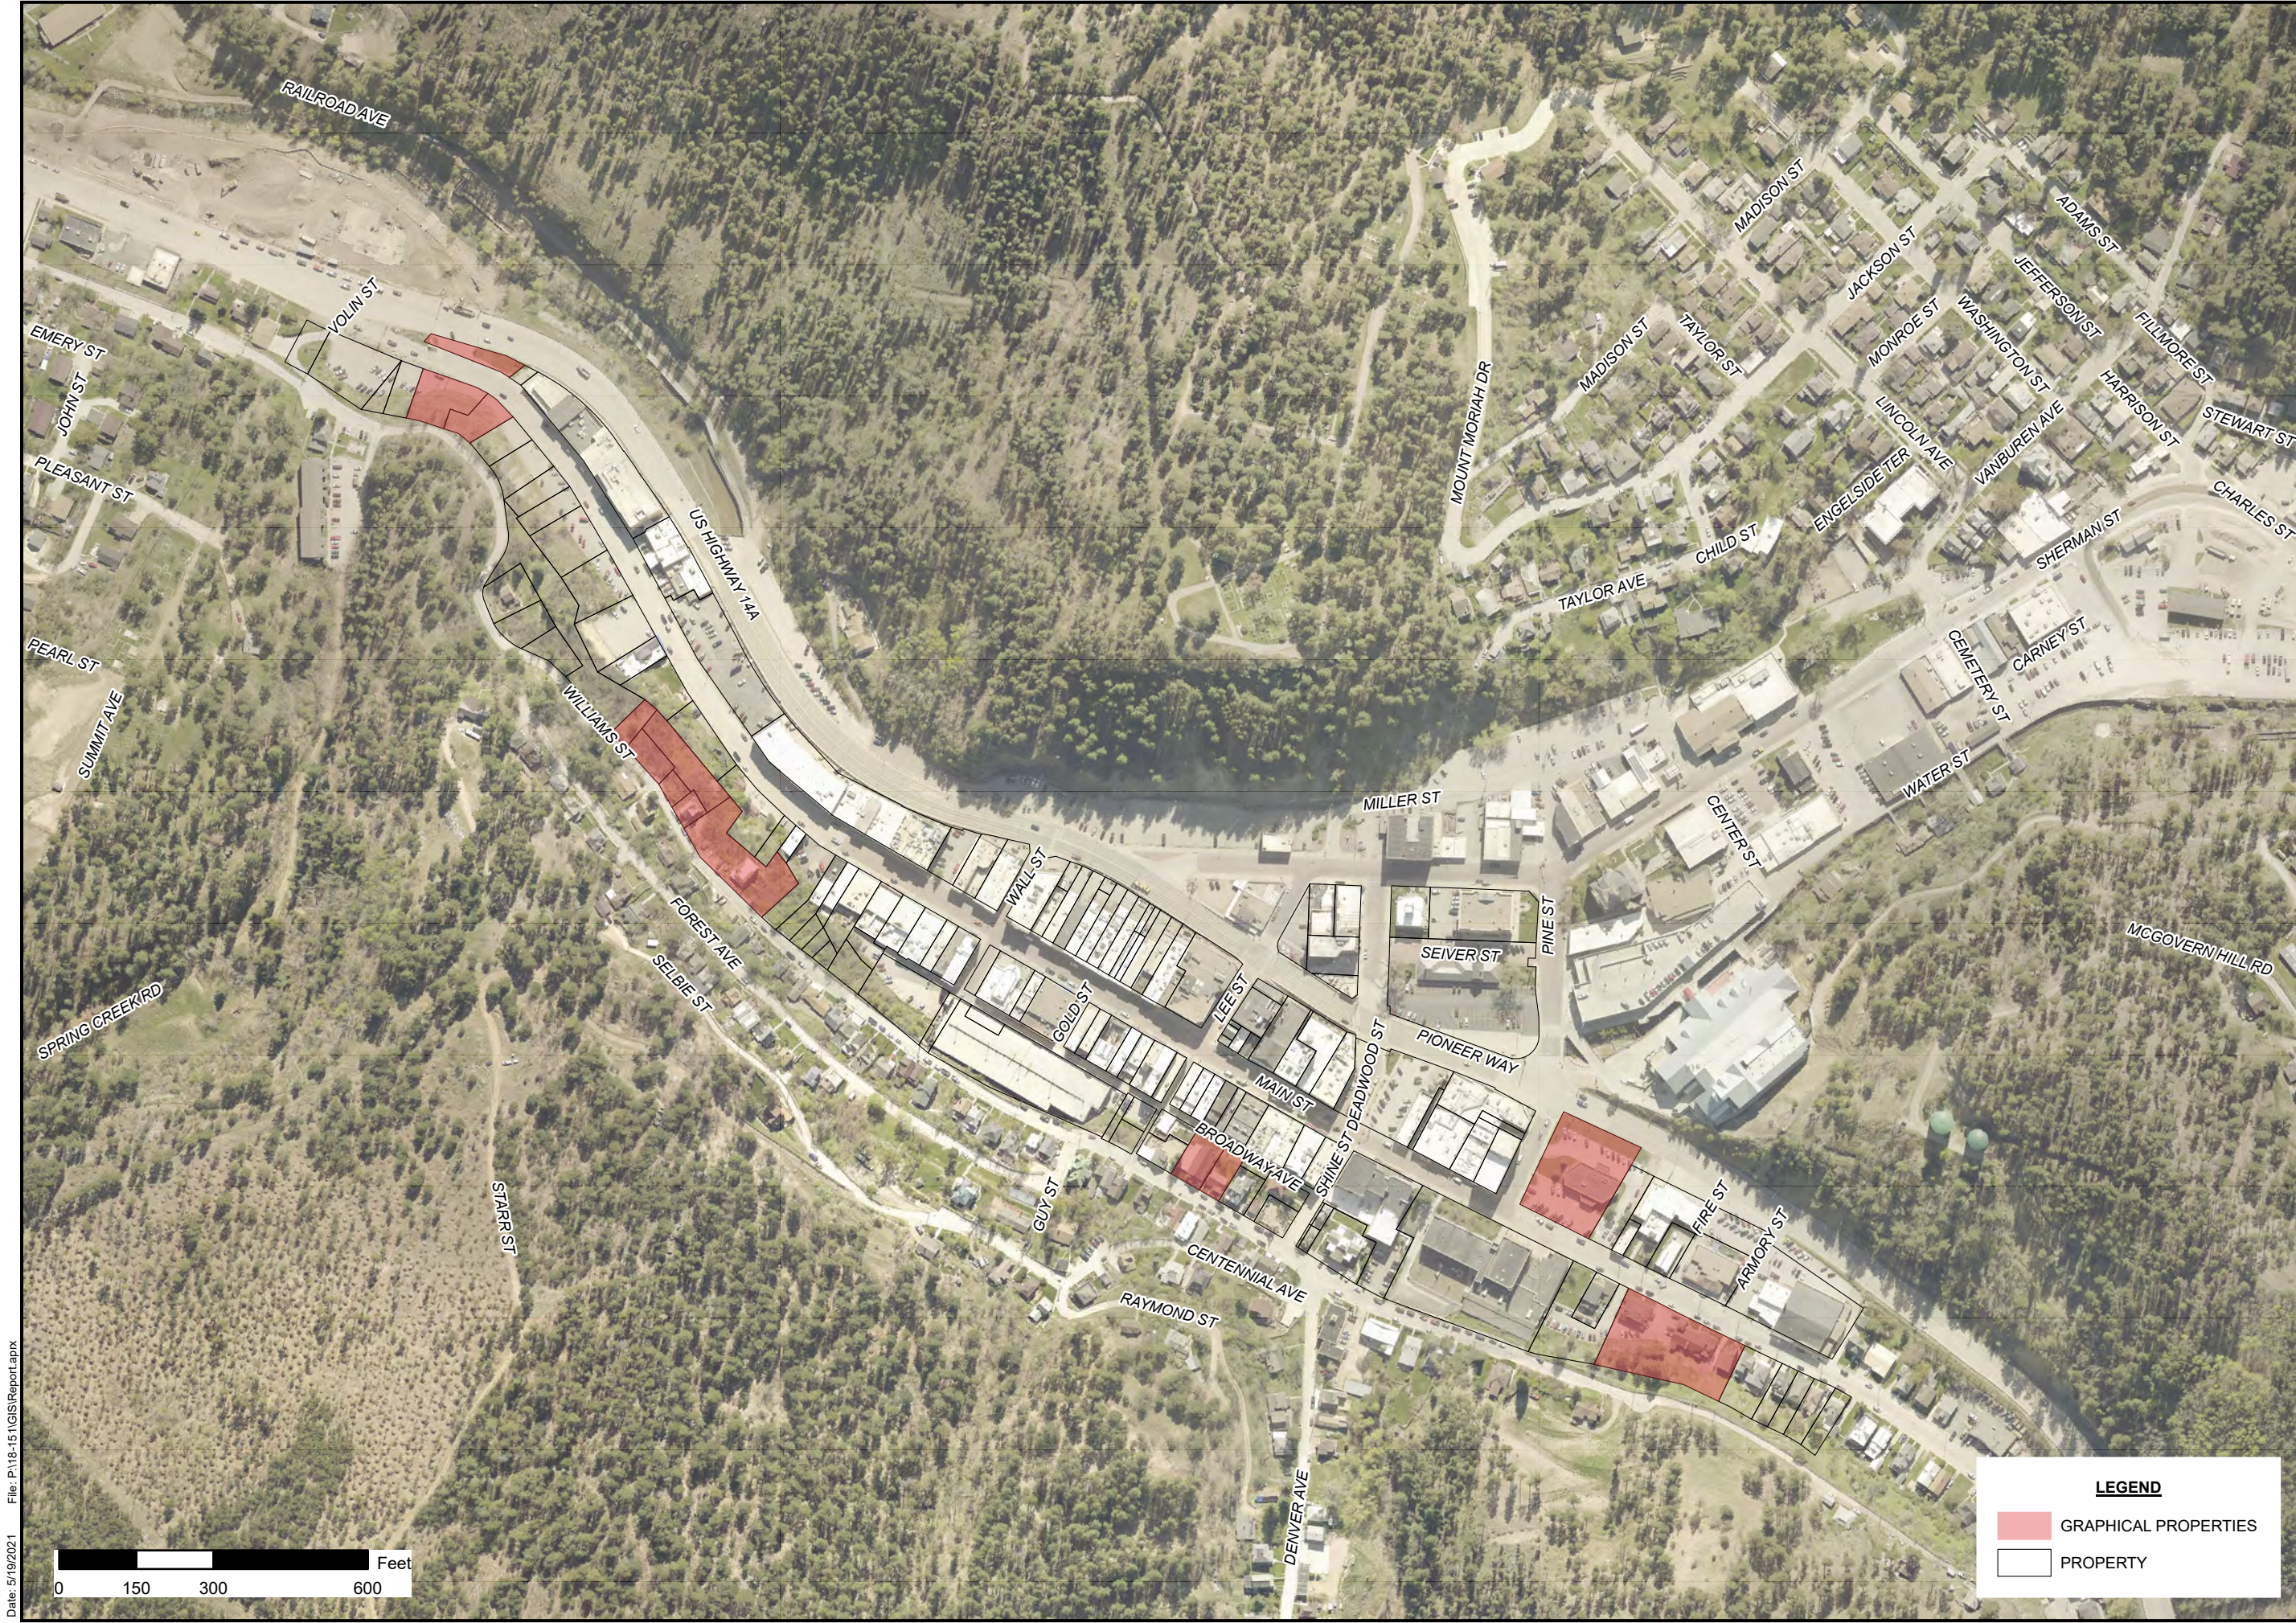
Sheet Title:
**FIGURE 1.
PROPERTY
RECONSTRUCTION**

base. As stated above, the primary focus was on establishing the Main Street Right-of-Way. **Figure 1** shows a map of the property as reconstructed.

There were a few properties in the project area that were lacking enough documentation and field evidence to definitively reconstruct and should be considered graphical in nature. These areas are shown highlighted in [Figure 1](#) and did not directly impact the reconstruction of the Main Street Right-of-Way. The Wells Fargo lot is highlighted, but it should be noted that the Main Street side of the bank lot was reconstructable. There was some ambiguity on the Highway 14A side of the lot. It should also be noted that interior lot lines, in many instances, are also graphical in nature.
